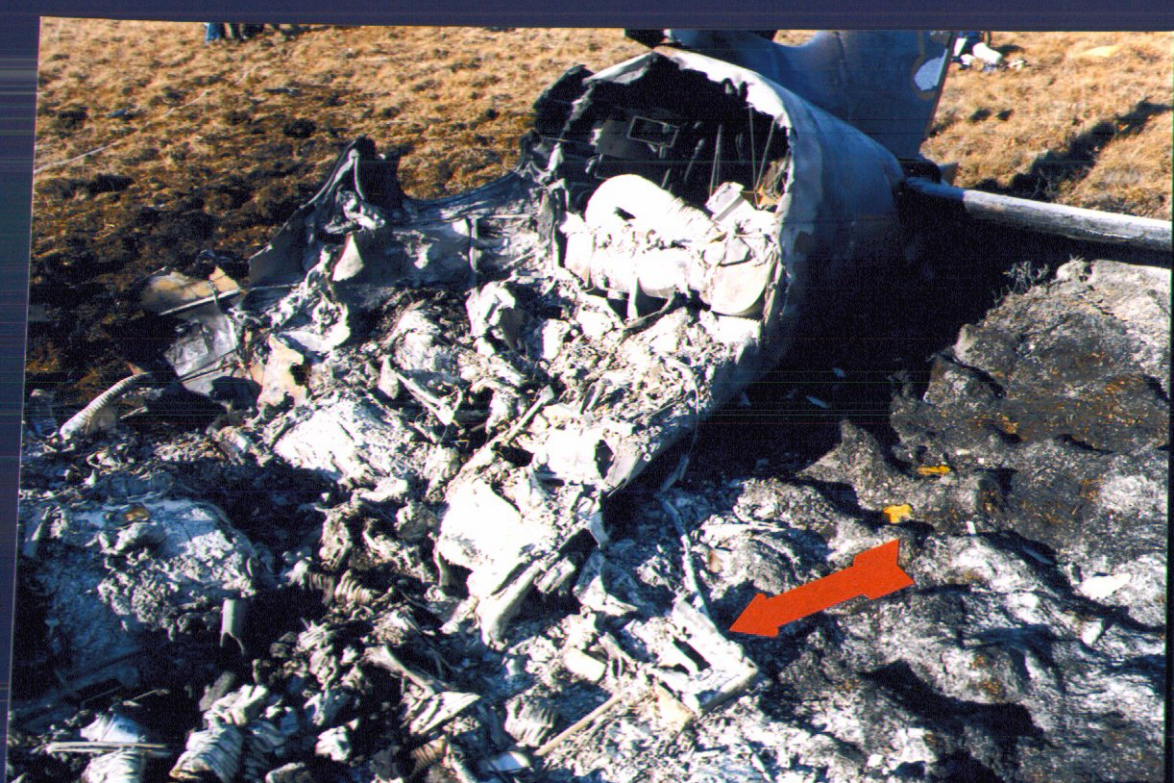
Photo 12: View of cabin area of airplane. Note fire damaged lower half of cabin door.
